July 20, 2015

RE: Lead-Based Paint Survey
St. John's Seminary
Drossards Hall, Margil Hall and St. Mary's Hall
SEC Mission Road and E. Mitchell Street
San Antonio, Texas
PSI Project No.: 0435-2317

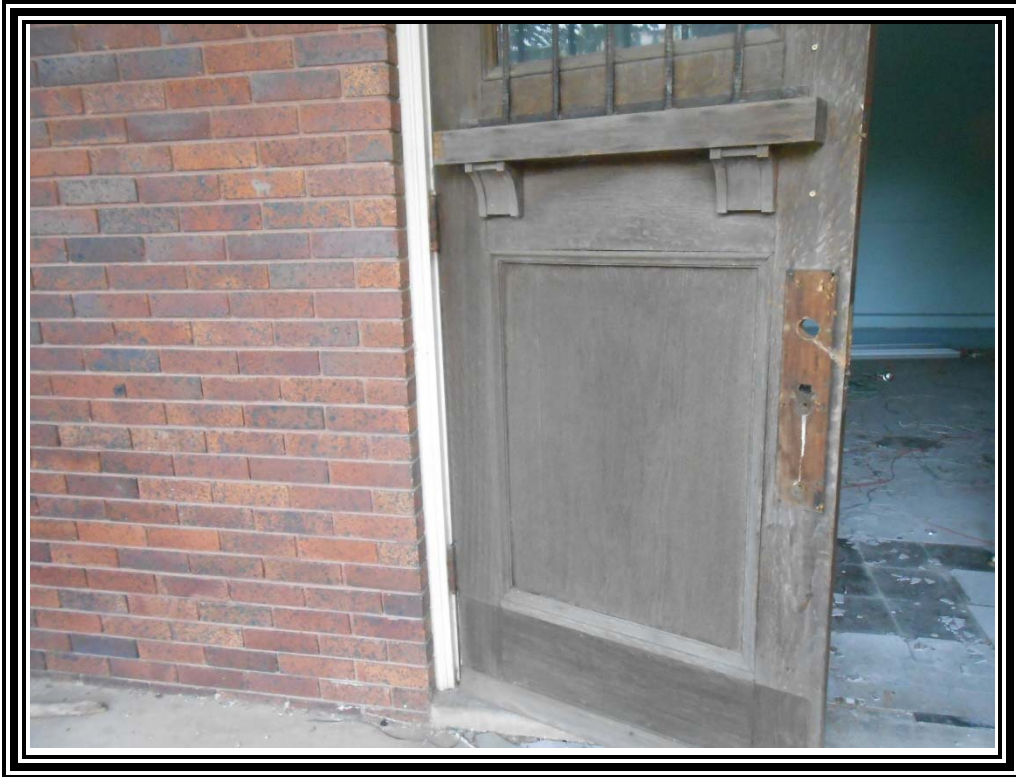
1. Door frame of front double doors of Drossards Hall.

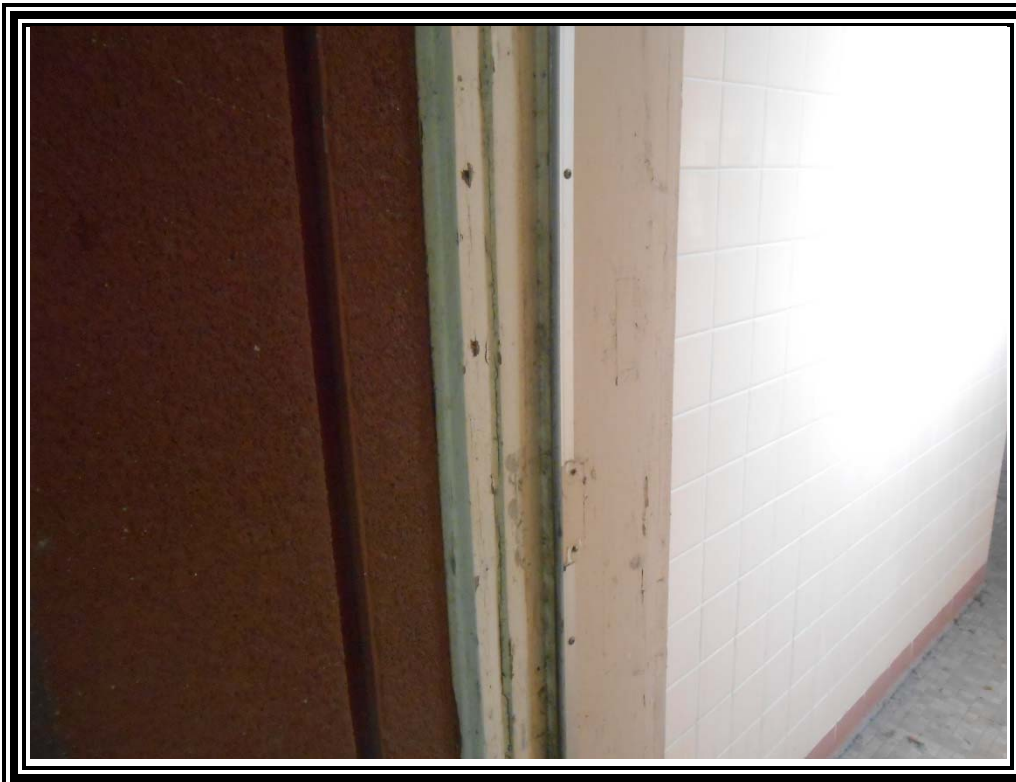
2. Door frame between restrooms and exterior of building of Drossards Hall.

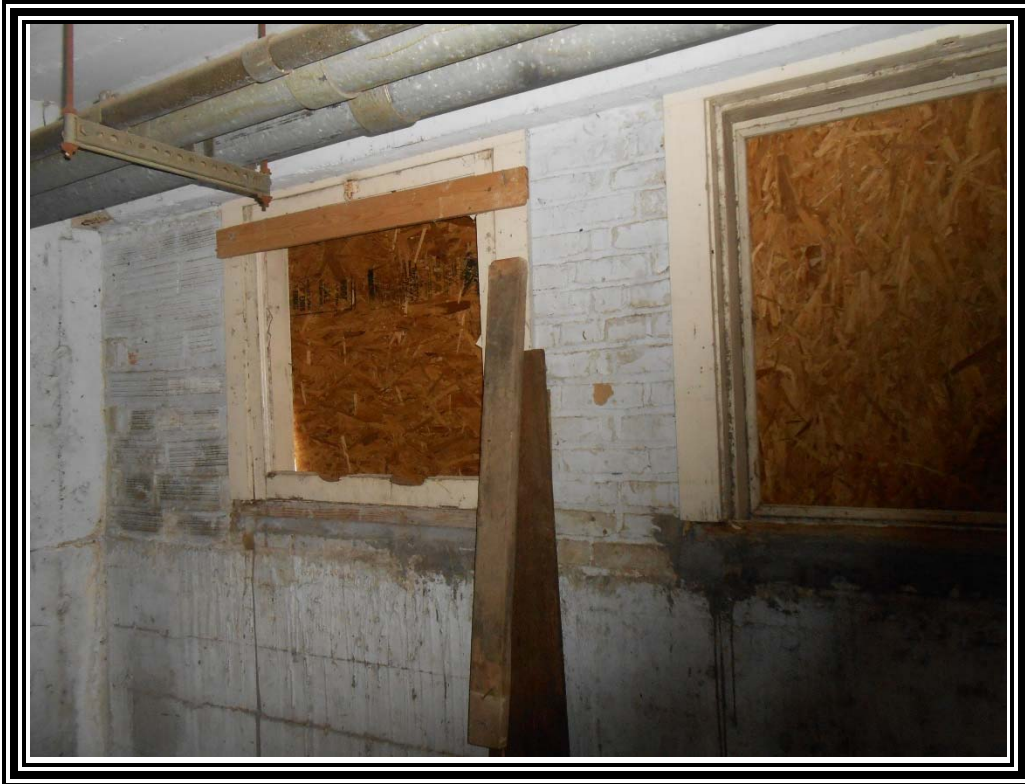
3. View of lead-containing paint on basement window frames of Drossards Hall.

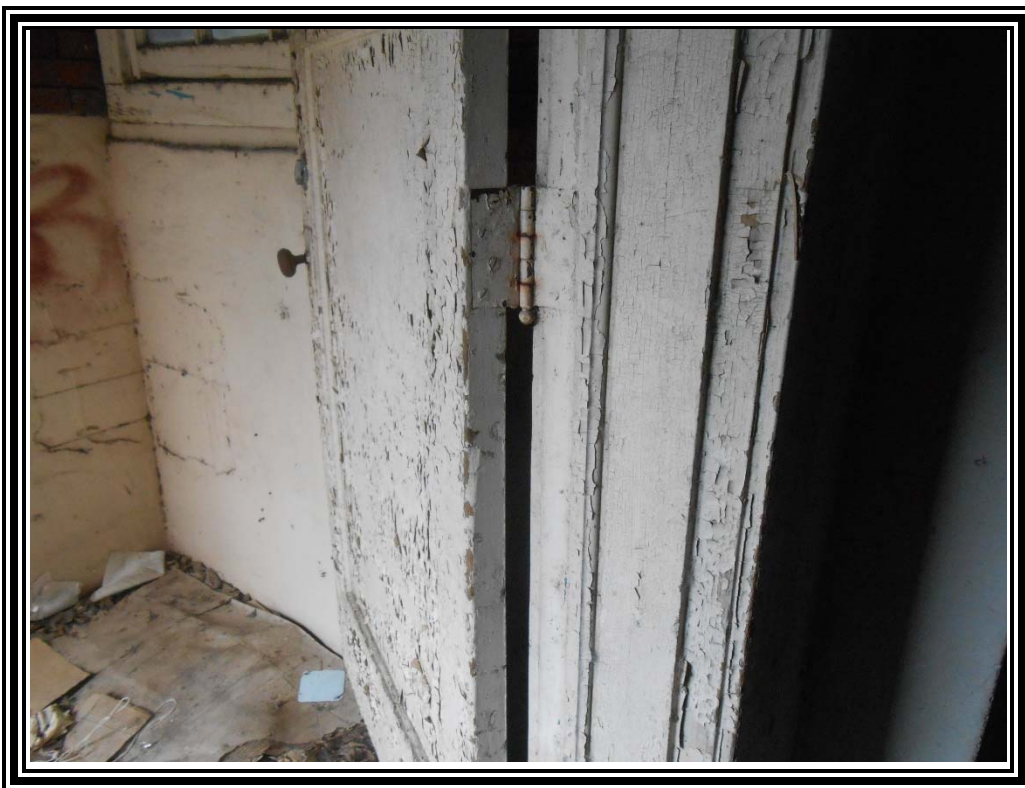
4. View of lead-containing paint on basement double door frame leading to the exterior of Drossards Hall.

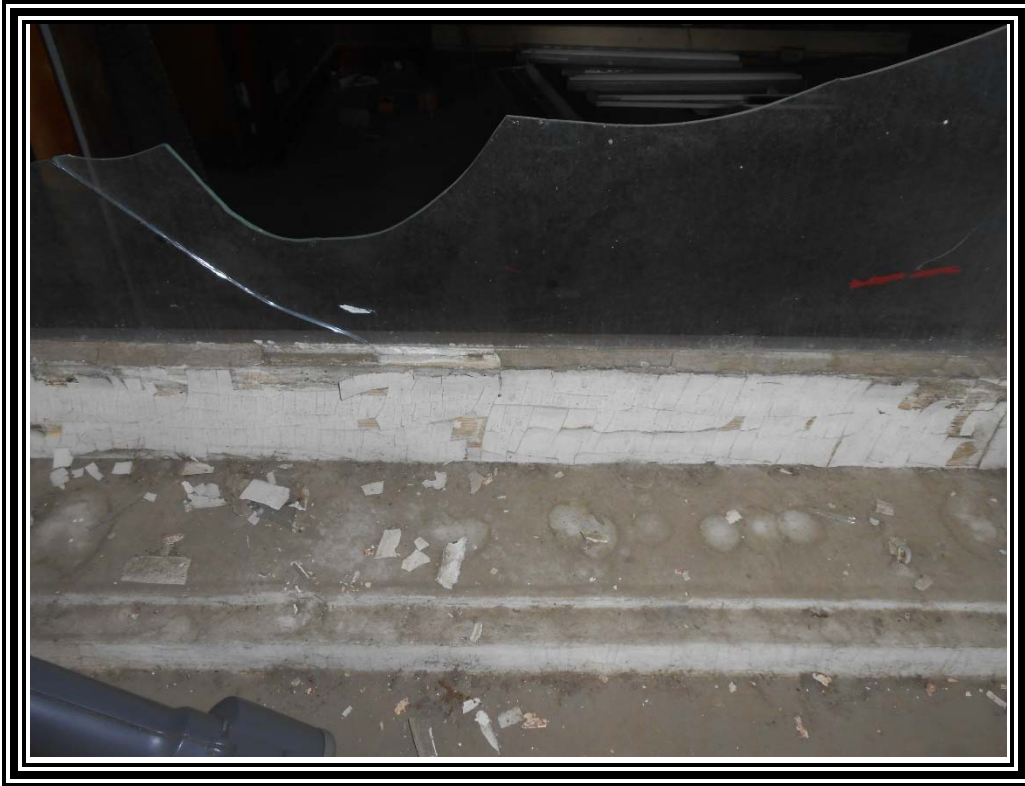
5. View of lead-containing paint on window frame and window sill near the entrance of Margil Hall.

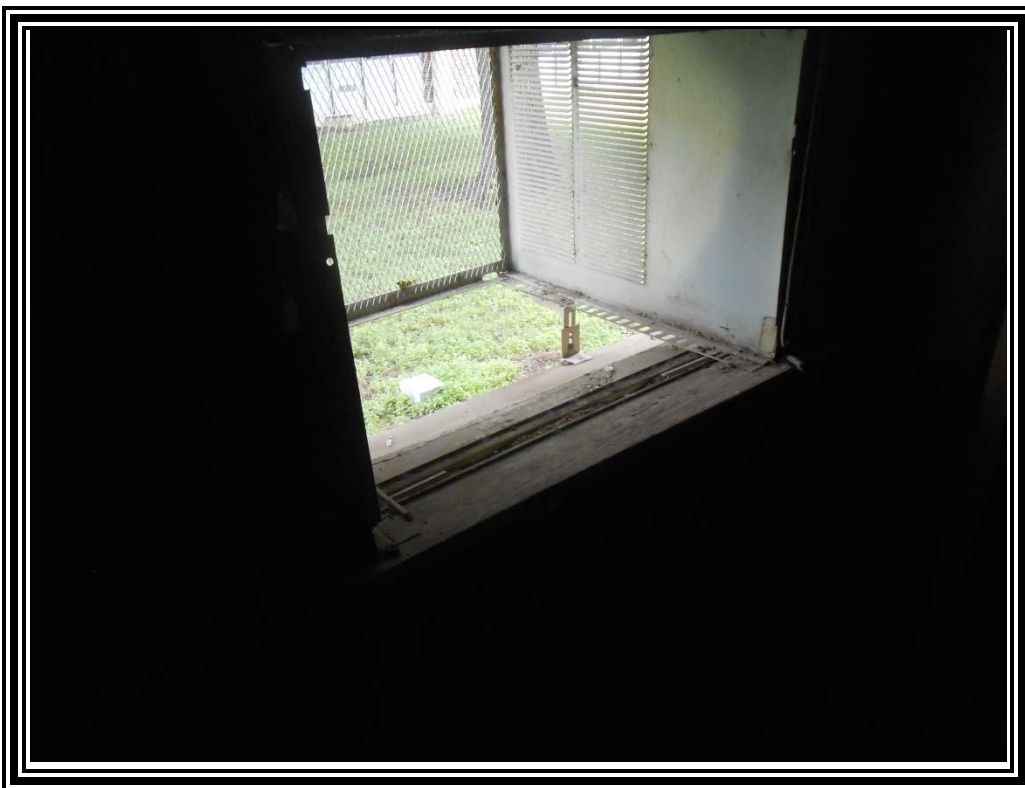
6. View of lead-containing paint on window frame on the exterior of an east side classroom of Margil Hall.
